MISCELLANEOUS PAPER S-69-29

EVALUATION OF HARVEY NONWELDED ALUMINUM LANDING MAT

July 1969

U. S. Army Engineer Waterways Experiment Station
CORPS OF ENGINEERS
Vicksburg, Mississippi

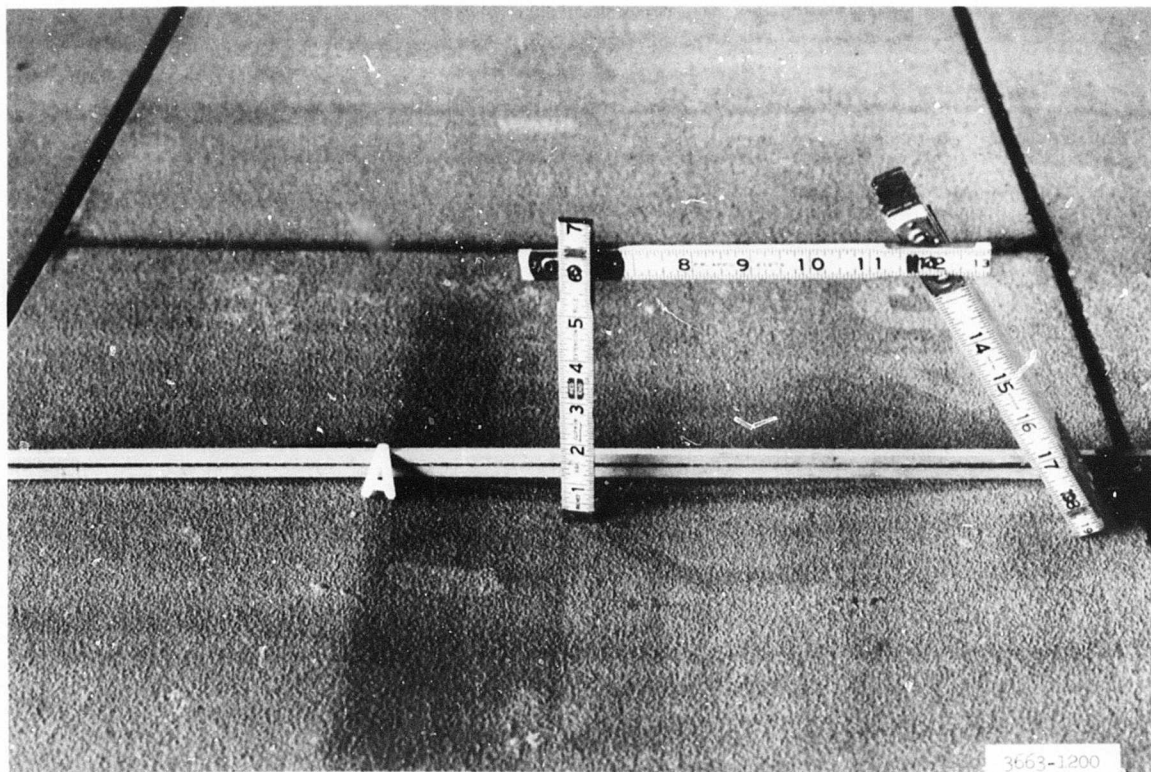
Fig. 5. Indicated internal damage in plank 40 after 16 coverages

31. No external damage was noticed in item 1 from 0 coverages to the time the test was stopped at 26 coverages. After 8 coverages of traffic, plank 40 in item 2 showed signs of severe internal damage, i.e. rib damage, and at 12 coverages, plank 38 showed signs of slight internal damage. Both planks 38 and 40 were replaced after 16 coverages because of internal damage, as shown in figs. 5 and 6. Internal failure in plank 40a, the replacement for plank 40, was noticed after two coverages of traffic. These failures were also caused by extrusion defects instead of the nonwelded joint configuration. Since this test program was mainly concerned with evaluating the performance of the nonwelded end connectors of the mat and not the

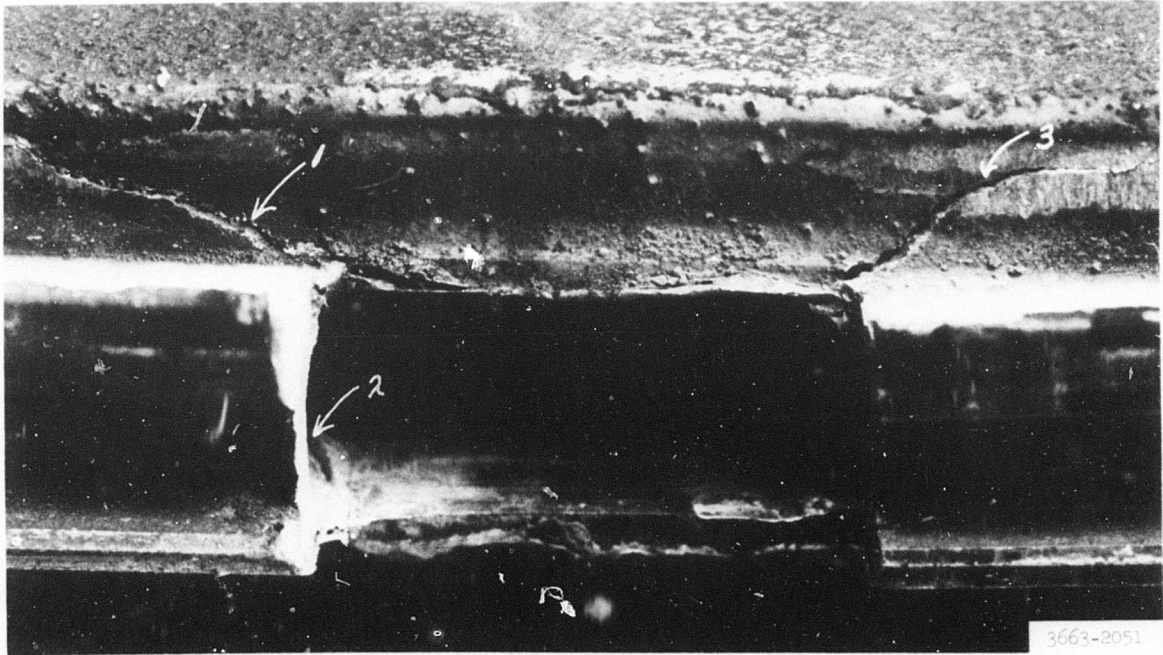
Fig. 7. Damage at notch in the modified mat at 187 coverages

bar (fig. 4) fitting into the notch cut in the male side connector of the plank in the adjacent run. Fig. 7 shows a close-up of the mat damage at a notch after 187 coverages of traffic. At the end of traffic, there were only five planks with breaks such as those labeled 1 and 3 in fig. 7, and one plank with a break such as that labeled 2 in fig. 7. These breaks were approximately 1 in. in length. Other damage that was observed when the mat was taken up was 18 C-rail splits that averaged 7-3/4 in., the longest being 13-1/2 in., and 1 to 12 ribs broken in 19 planks. The maximum deformation measured in item 2 after traffic was 0.5 in. A plot of deformation along the center line of the traffic lane is shown in plate 7.

- d.* The extended web of the locking bar used with the modified mat, which fitted into the notch in the male side connector, kept the mat planks from moving laterally but did not reduce the mat damage occurring at the end joints.

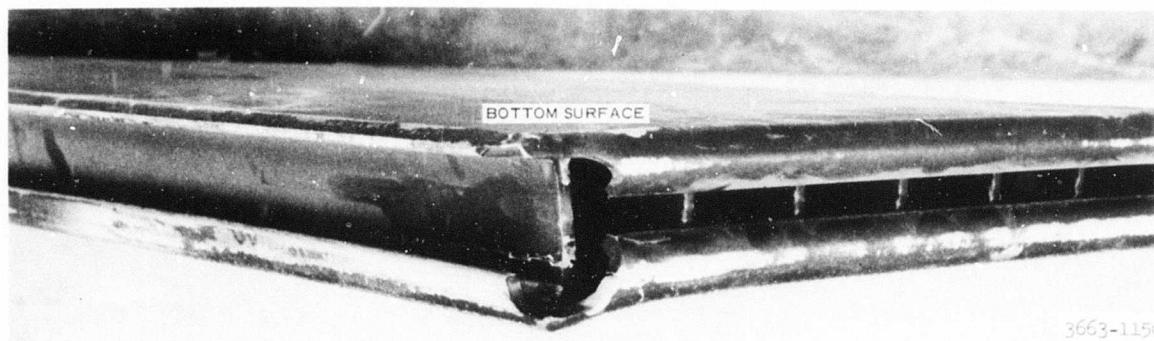
Photograph 3. End-curl split

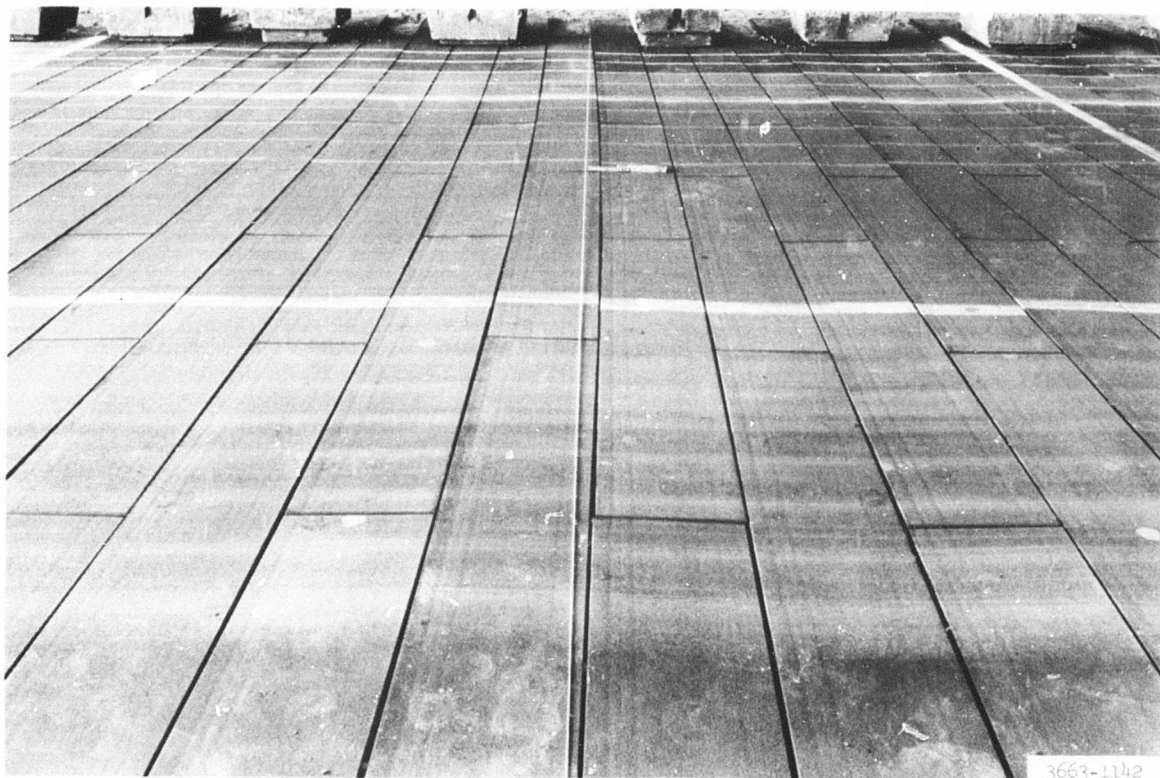
Photograph 8. Bow (2-1/2-in.) in mat after 100 coverages on items 1 and 2

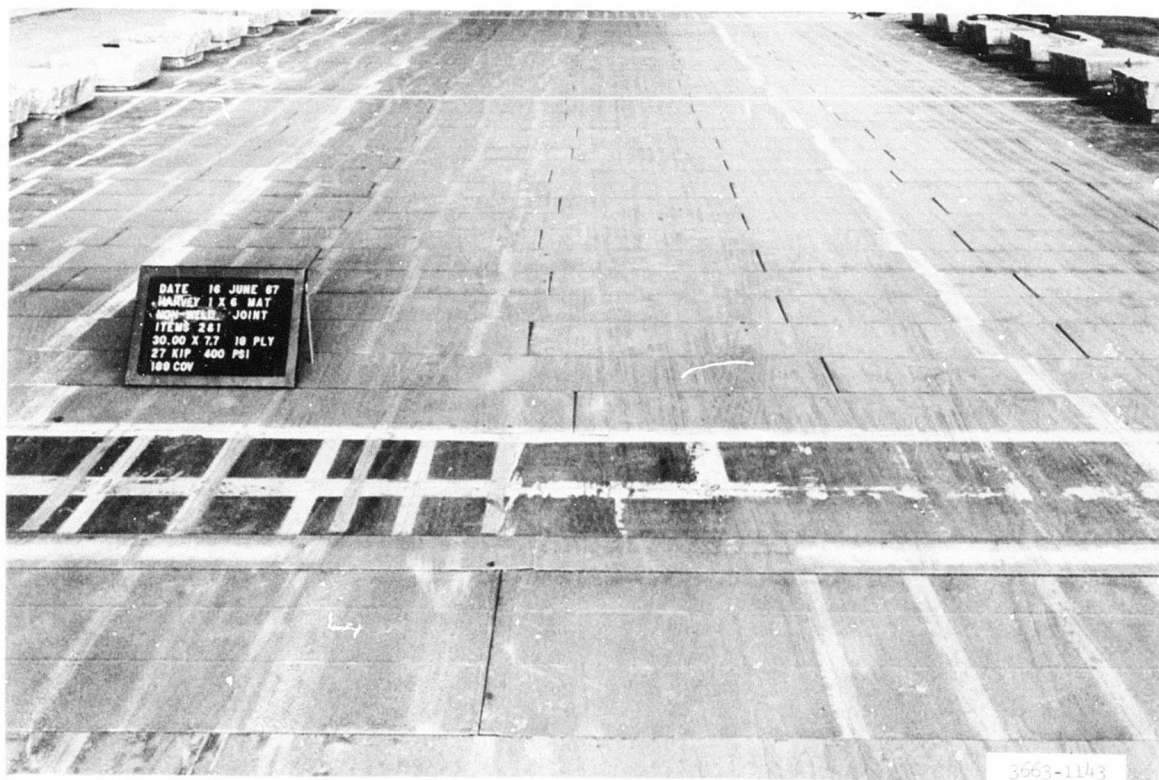
25. Item 1 was in fair condition and item 2 was in good condition at 188 coverages. The only apparent damage observed at this time was the curl of the end connectors on 11 planks in item 1 and 4 planks in item 2. Photograph 9 shows the test section after 188 coverages of traffic. Twenty-seven planks were taken up in item 1 after 188 coverages in order that the CBR could be checked and a partial break count could be taken. There were 31 C-rail splits out of 32 possibilities in the 27 planks inspected. These splits varied in length from 3/4 to 4 in. with an average of about 2-1/4 in. These small breaks could not be detected until the mat was taken up and would not have caused any operational problems.

Photograph 9. Test section 1 after 188 coverages

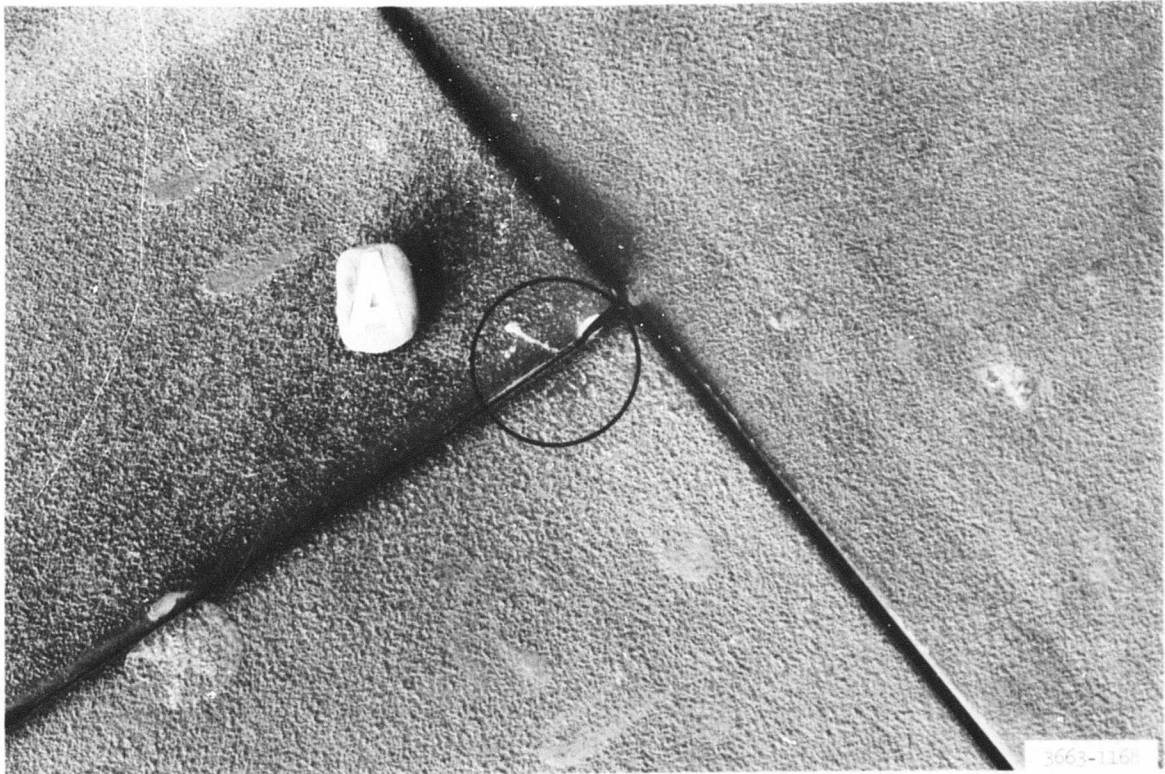
26. Traffic was continued on the test section to 298 coverages, at which time item 1 was considered failed. Although the top surface of the mat was in fair condition at 298 coverages, interior breakage of the mat was evidenced by skin tears and loud crackling noises as the load cart passed over the broken planks. The only visible damage in item 1 after 298 coverages was small top skin tears, as shown in photograph 10, which appeared on nine planks, and two planks showed end-curl splits. All the end connectors in both items had a small amount of curl but not enough to cause a traffic hazard. A general view of the test section at failure is shown in photograph 11.

Photograph 10. Skin tear in plank 11 after 298 coverages; item 1, lane 1

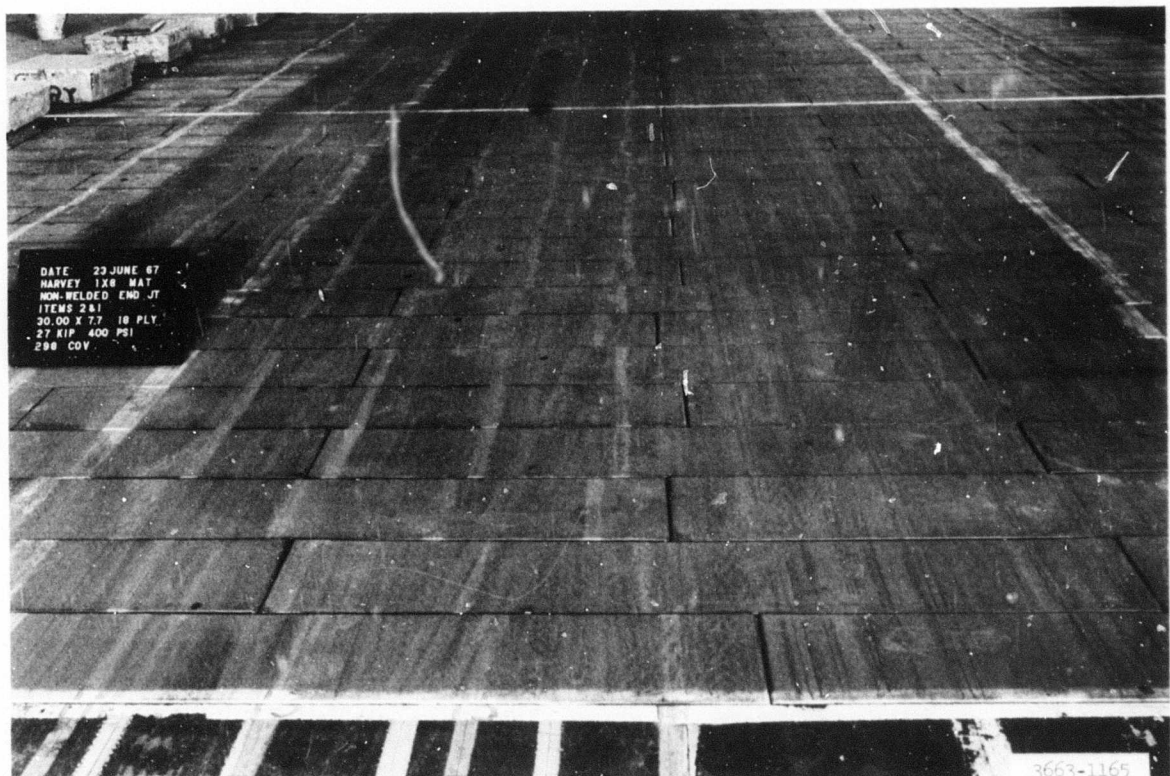
27. The mat was taken up and inspected after 298 coverages. The mat damage found in item 1 during this inspection was 60 C-rail splits varying in length from 2-1/4 to 8-1/4 in. and averaging 5-1/8 in., 20 end-curl splits about 1 in. long, and 51 ends of the planks in the traffic lane with one to six interior ribs broken. Ten of these planks were considered failed due to large C-rail splits and broken interior ribs at the end joints. The damage recorded in item 2 was 54 C-rail splits varying in length from 1 to 6 in. and averaging 3-3/8 in., 4 end joints with end-curl splits of about 1 in., and 21 planks with one to six broken interior ribs. There were two plank failures in this item due to C-rail splits and broken ribs.

Photograph 11. Test section 1, lane 1, after 298 coverages (failure)

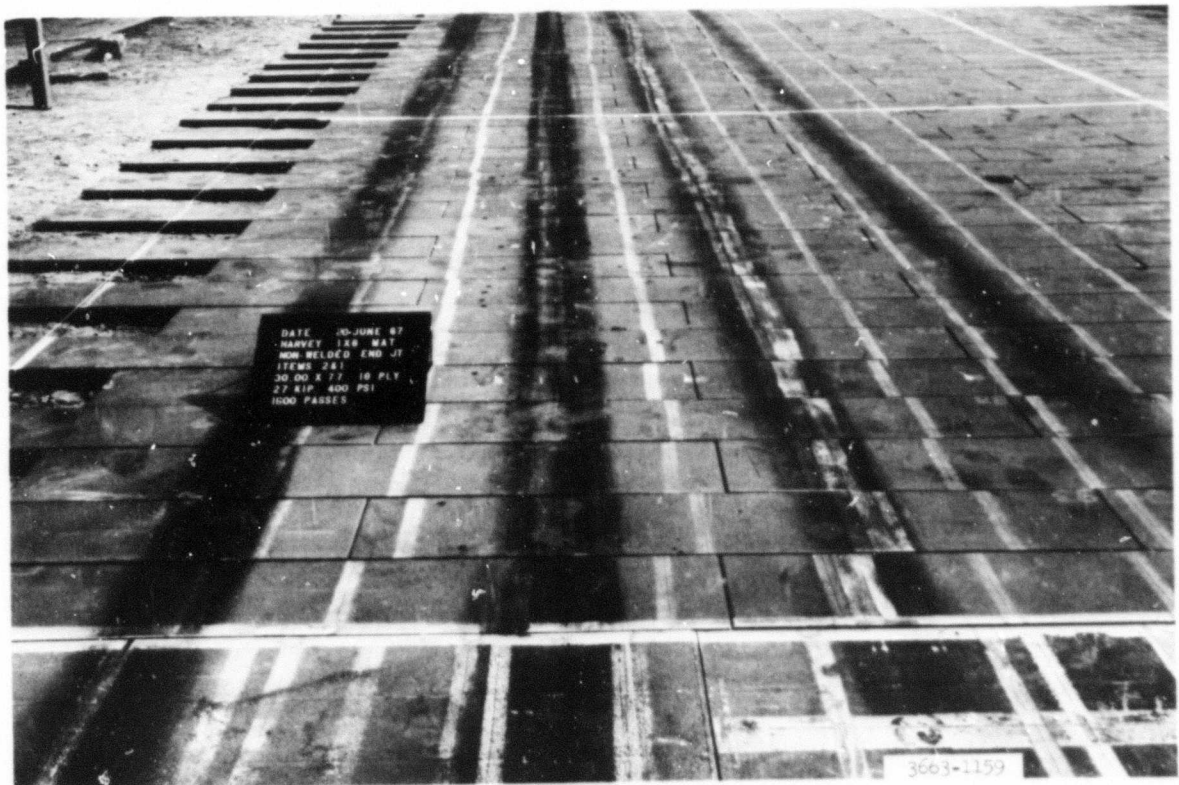
Photograph 13. Test section 1, lane 2, after 1600 passes

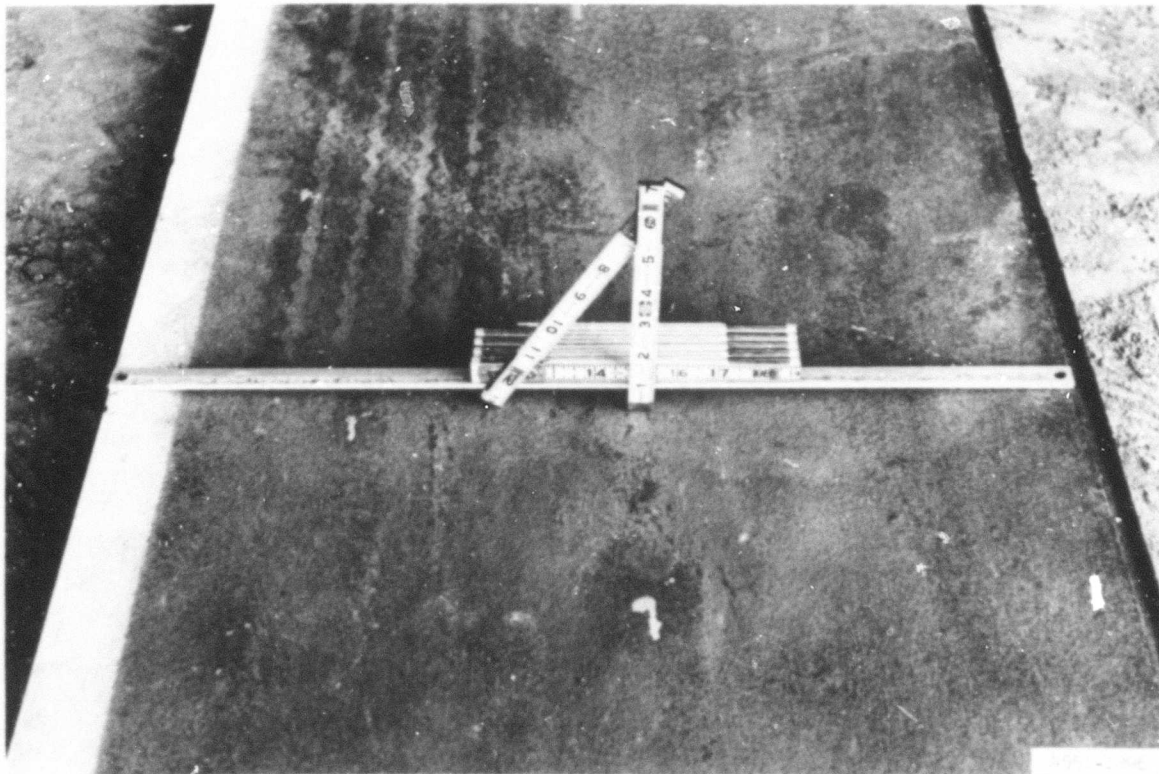
30. After 12 coverages of traffic, the mat planks in item 1 were dished from $\frac{3}{8}$ to $\frac{1}{2}$ in. The dish in the mat planks in item 2 ranged from $\frac{1}{8}$ to $\frac{1}{4}$ in. Photograph 14 shows the dish in plank 2 after 16 coverages. This dishing was caused by defects in the internal ribs, not by the nonwelded joint configuration. Therefore, traffic was stopped after 16 coverages of traffic upon the request of a Harvey representative with the concurrence of WES and NAEC. The mat was then taken up and shipped back to the factory for inspection by the fabricator. Harvey replaced this mat with new 2- by 6-ft nonwelded mat for further tests.

Photograph 14. Dish in plank 2 after 16 coverages; test section 2, item 1, lane 1

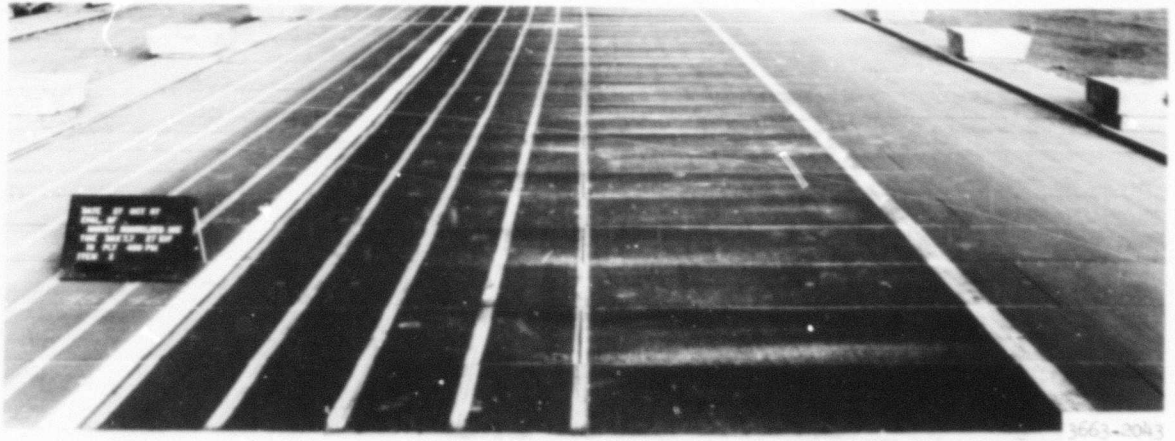
33. Although there was only one break on the top surface of the mat after 187 coverages, this item was considered failed due to severe dishing, which caused a very rough surface. The mat in this condition is a safety hazard when used with a catapult system because of the possibility of the arresting hook on the aircraft catching mat edges rather than the cable. Photograph 16, depicting item 2 after 187 coverages, shows that there was very little lateral movement of the mat planks during the course of 187 coverages of traffic. Lateral movement of the mat was prevented in this item by the web extrusion of the locking

Photograph 16. General view of item 2, section 3, after 187 coverages

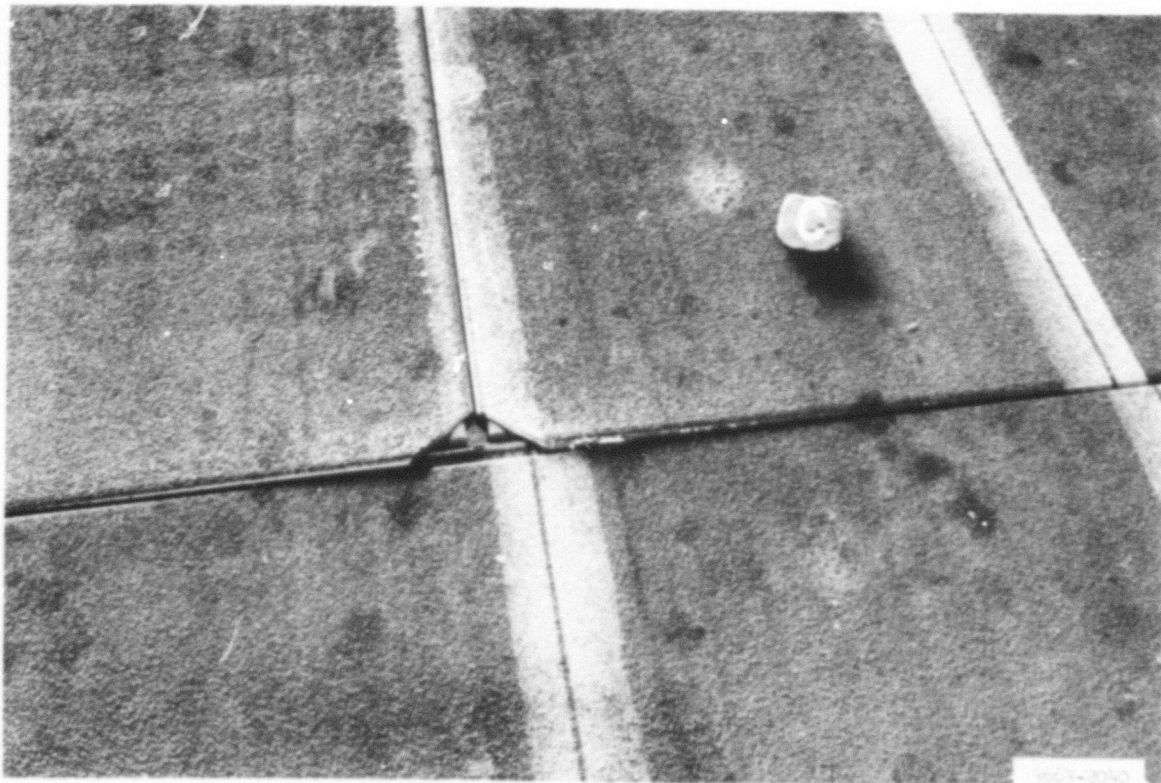
Photograph 18. Lateral movement of the mat planks after 68 coverages of traffic; item 3, section 3

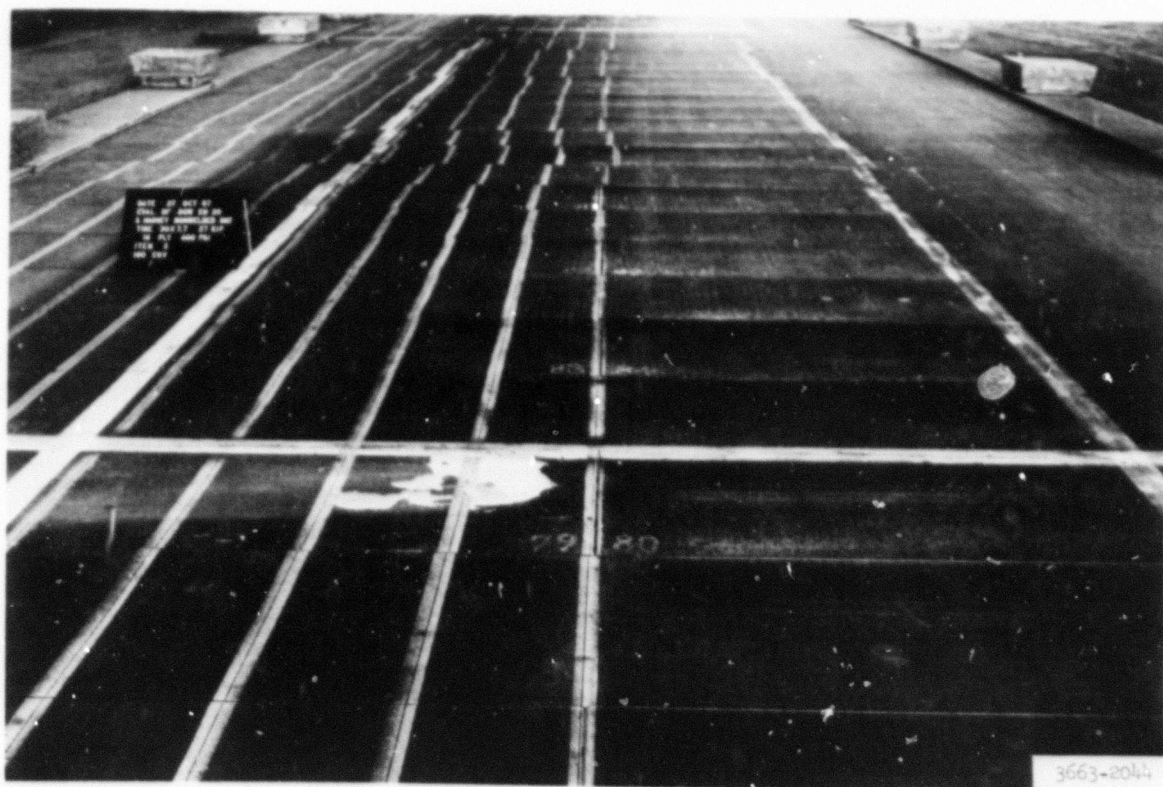
34. A general view of item 3 prior to traffic is shown in photograph 17. After 10 coverages, a maximum dish of 3/16 in. was measured in this item on several mat planks with end joints in the traffic lane. At 14 coverages, the top lip of the C-rail at the end joints had begun to curl up on the mat planks. The largest curl measured was 7/32 in. The first mat breakage occurred at 58 coverages when a small crack appeared in the C-rails of planks 83 and 84. After 68 coverages, photograph 18 was taken showing the lateral movement of the mat planks in this item as opposed to very little movement in item 2. A popping noise, which usually indicates internal damage, was heard at 100 coverages of traffic as the test cart rolled up and down the item across the end joints. Fifteen of the twenty end joints in the traffic lane had broken C-rails at this time. Dishing had developed in all the planks with end joints in the traffic lane, with a maximum dish of 3/8 in. measured in three planks. The only other damage observed after 100 coverages was a small skin tear on plank 84. After 120 coverages, seven planks were in poor condition due to dishing, skin tears, and the curling of the upper lip of the C-rail. The dish in these planks ranged from 3/8 to 1/2 in., the average length of the skin tears was 1/2 in., and the height of curl was approximately 1/2 in. At 160 coverages, this item was considered failed. A general view of item 3 at failure is shown in photograph 19.

Photograph 19. Item 3, section 3 in background, after 160 coverages of traffic (failure)

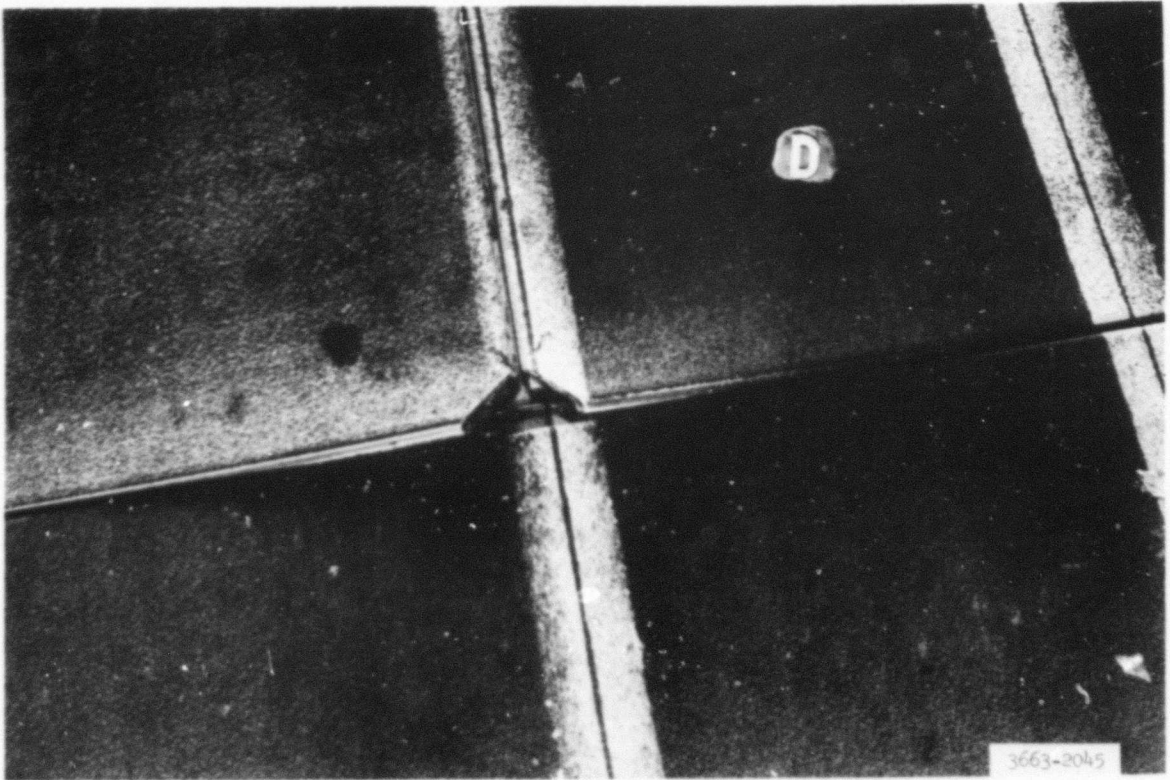
35 When traffic was stopped, the top skins of 16 planks were slightly torn, all 20 of the end joints in the traffic lane had curled top lips of the C-rail such as that shown in photograph 20, and there were 19 C rail splits averaging approximately 7-1/4 in. in length. Ten planks were failed due to a dish of 1/2 in. or more. The dish in plank 103 after 160 coverages, which indicated rib failure, is shown in photograph 21. During the inspection after traffic, 18 planks (all in the even-numbered runs) were found to have 4 to 12 broken ribs at the end joints. The maximum mat deformation measured in item 3 after traffic was 0.4 in. A plot of deformation along the center line of the traffic lane is shown in plate 7.

Photograph 20. Curl of top lip of C-rail (due to break in C-rail) and break in top skin of the end connector after 160 coverages; item 3, section 3

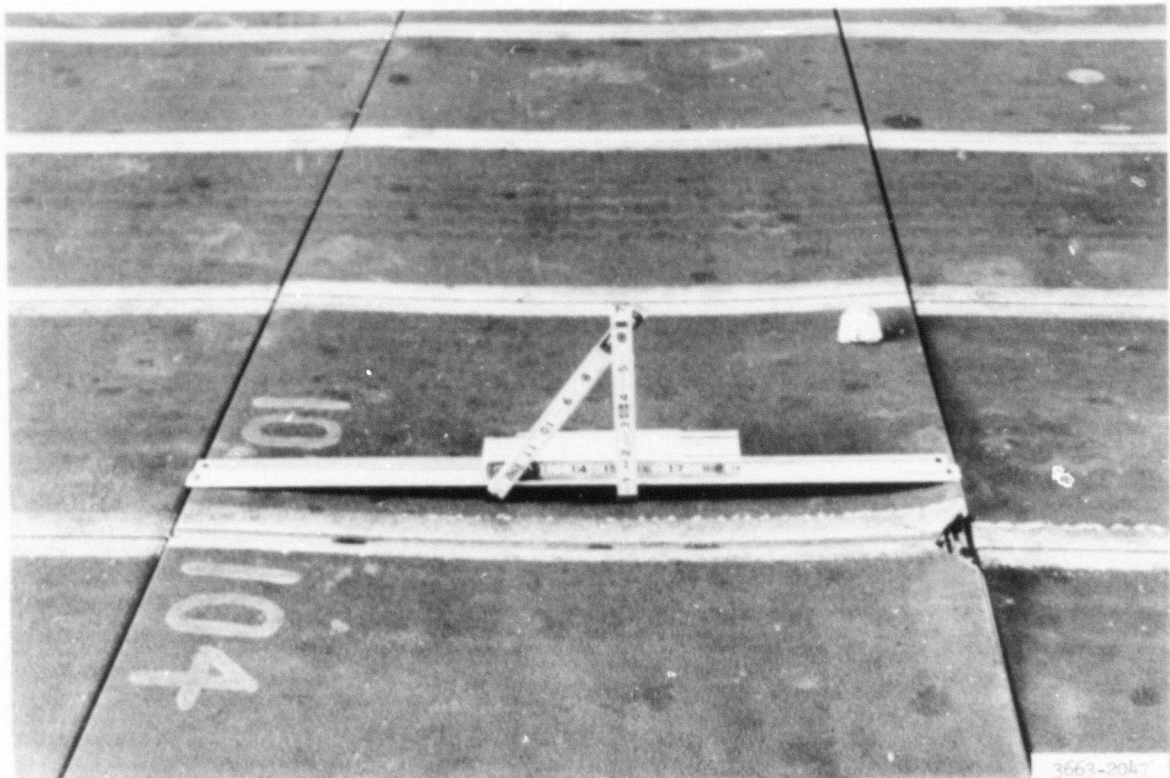
Photograph 21. Dish in plank 103 after 160 coverages; item 3, section 3
